## ADVISORY CIRCULAR 43-16A

# AVIATION MAINTENANCE ALERTS

**ALERT  
NUMBER  
300**

**JULY  
2003**

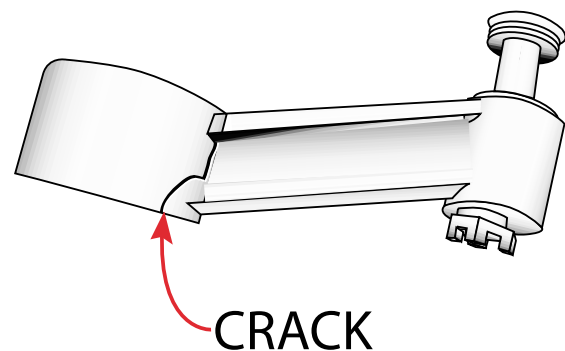
The technician discovered the nose landing gear actuator arm (P/N 35-825174), which attaches to the landing gear transmission box, had cracked. The crack allowed the arm to flex and rotate on the splines of the transmission shaft, which kept the push-pull tube to the nose gear in the forward position. (Refer to the illustration.) This actuator arm is also installed on several Beech aircraft models.

The submitter suspects that fatigue caused the actuator arm to crack. He recommends removing the actuator arm at the next inspection and inspecting the area using 10x-magnifier.

Part total time unknown.

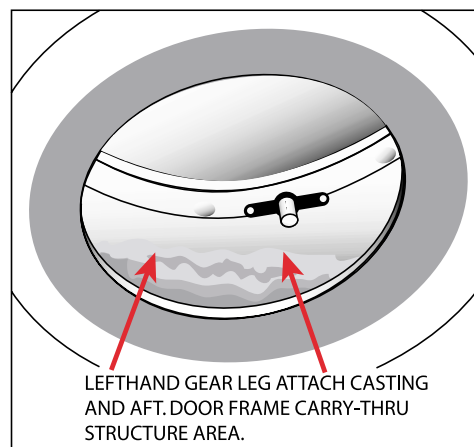
**CESSNA****Cessna; Model 182S; Skylane; Carpet; ATA 2500**

During a phase inspection, the technician discovered the flame retardant (fire block) on the aft carpet (P/N 0715093-2) was breaking down and coming loose.

The technician discovered the fire block had settled into the overlapping seams of the floorboard and the floorboard structure. He also found signs of corrosion in the areas where the fire block had accumulated. (Refer to the illustration.)

The submitter stated that if this defect was left unattended, it would cause further metal deterioration.

Part total time-1,790 hours.
